MISCELLANEOUS PAPER SL-81-28

# TENSILE TESTS ON ARTICULATED CONCRETE MATTRESS SPECIMENS

Structures Laboratory

Final Report

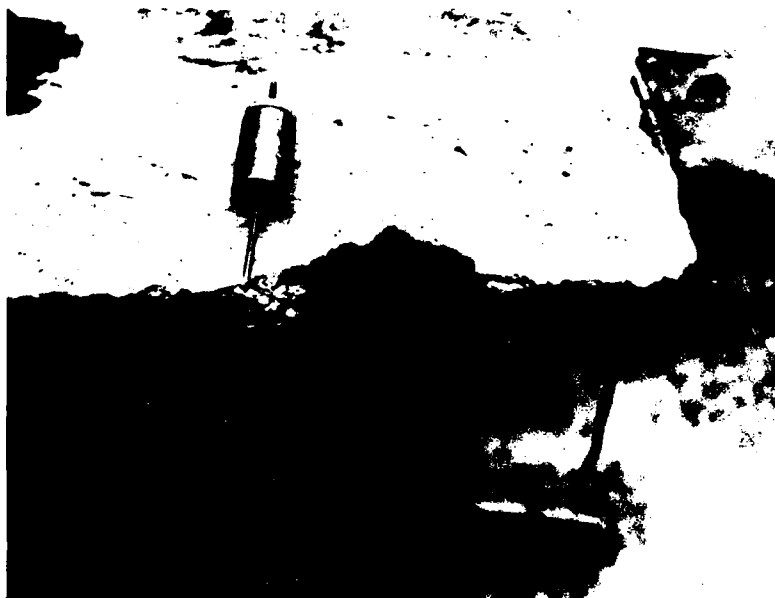
Figure B1. Panel 1, 3700-lbf load (ultimate)

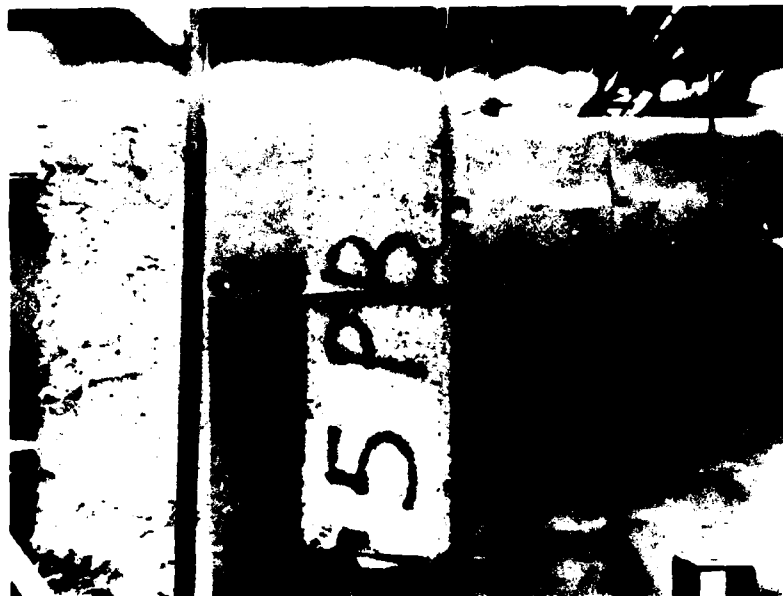
Figure B3. Panel 5, 3300 lbf load (ultimate)

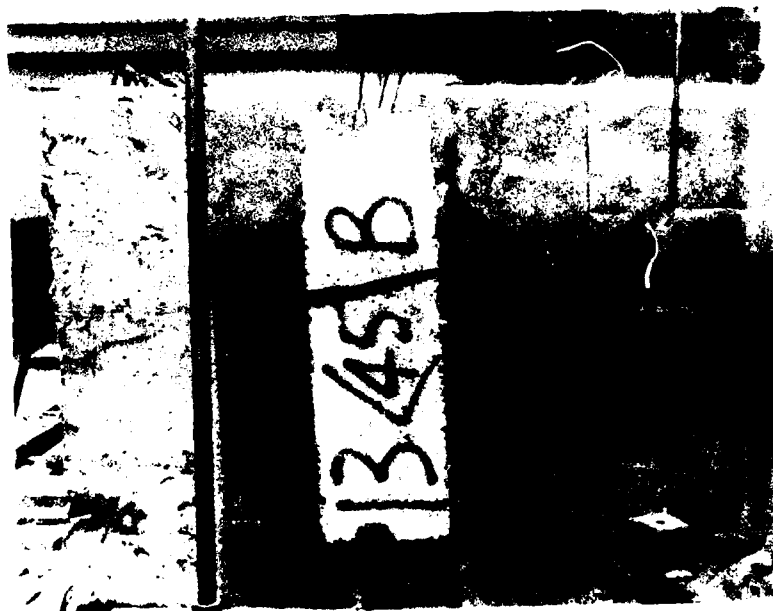
Figure B22. Panel 13, 3250 lbf load (ultimate)

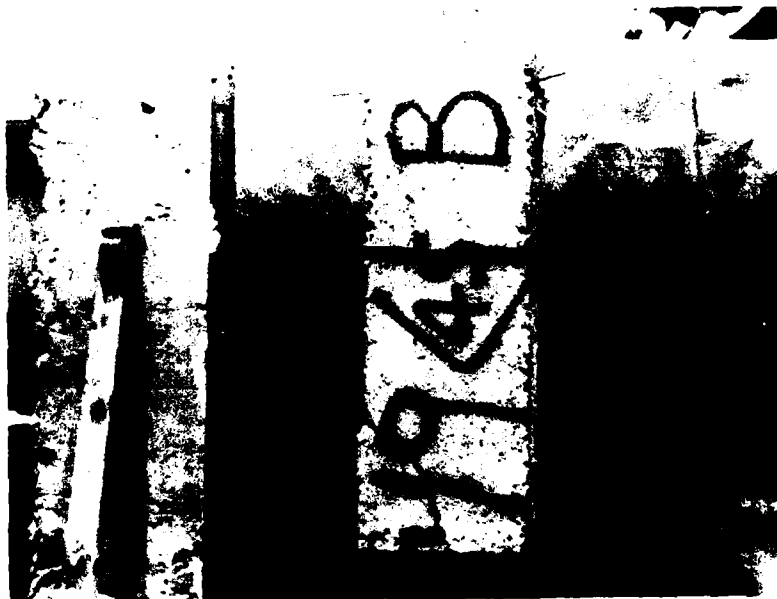
Figure B31. Panel 19, 3510 lbf load (ultimate)

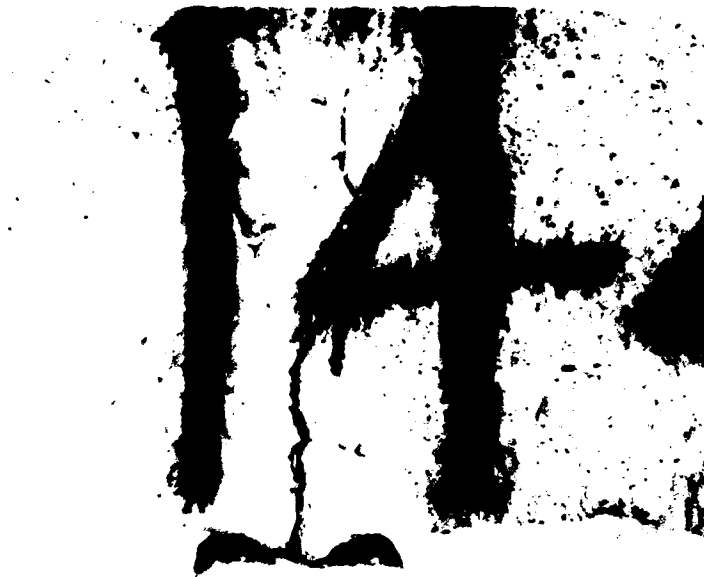
Figure B35. Panel 14, 3000 lbf load

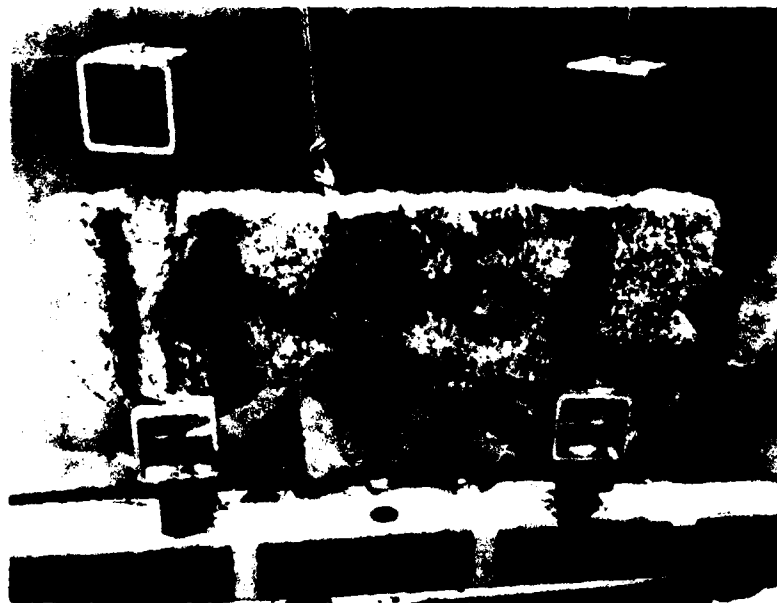
Figure B36. Panel 14, 4025 lbf load (ultimate)

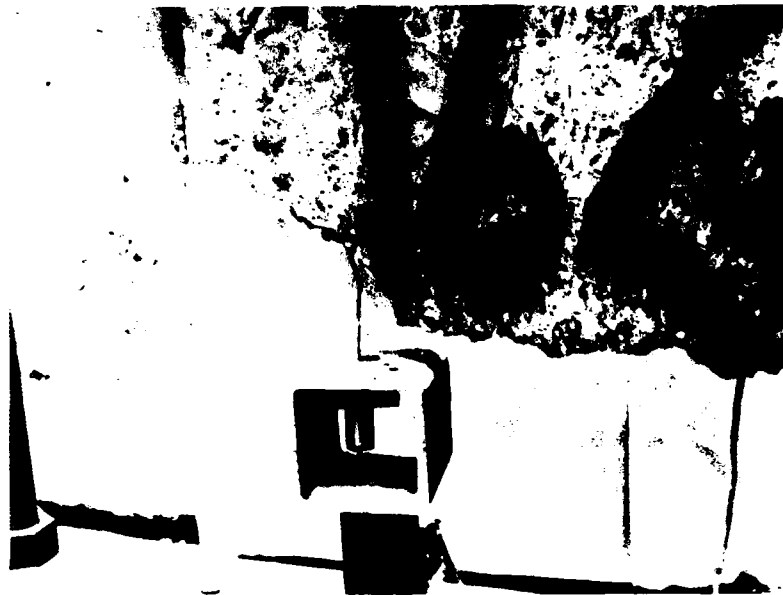
Figure B37. Panel 16, 3175 lbf load

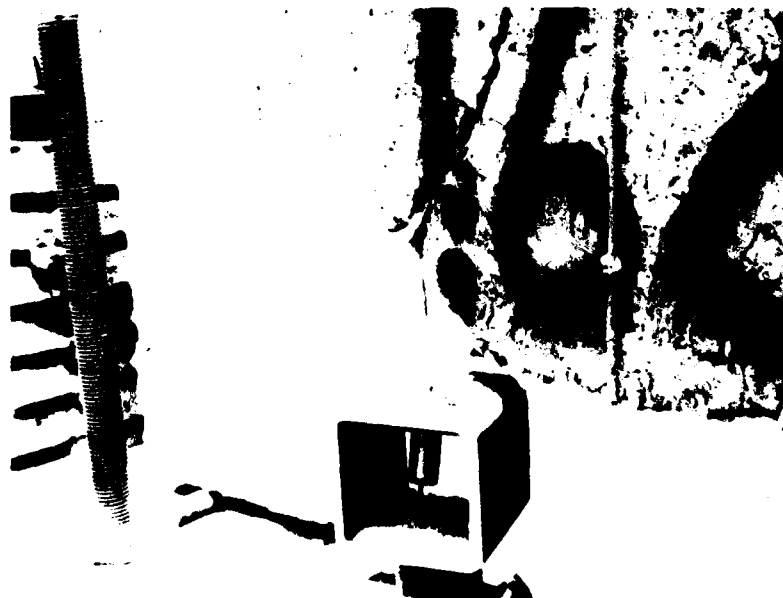
Figure B38. Panel 16, 3775 lbf load

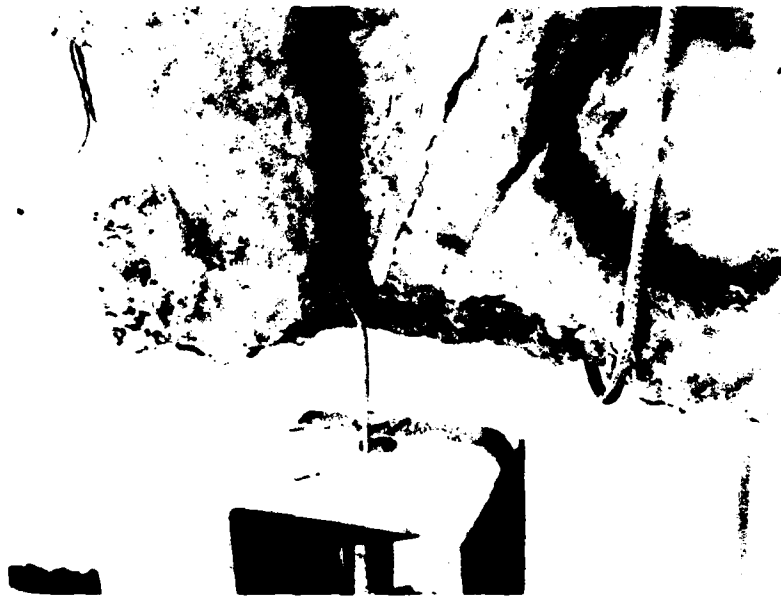
Figure B40. Panel 18, 2200 lbf load
